**NONDESTRUCTIVE ANALYSIS OF  
SALES GAS LINE PIPE EVIDENCE  
FROM THE WEST COTE BLANCHE  
BAY PIPELINE RUPTURE INCIDENT**

**Prepared For The  
NATIONAL TRANSPORTATION  
SAFETY BOARD  
Washington, DC**

**FEBRUARY 27, 2007**

**PN 131454**

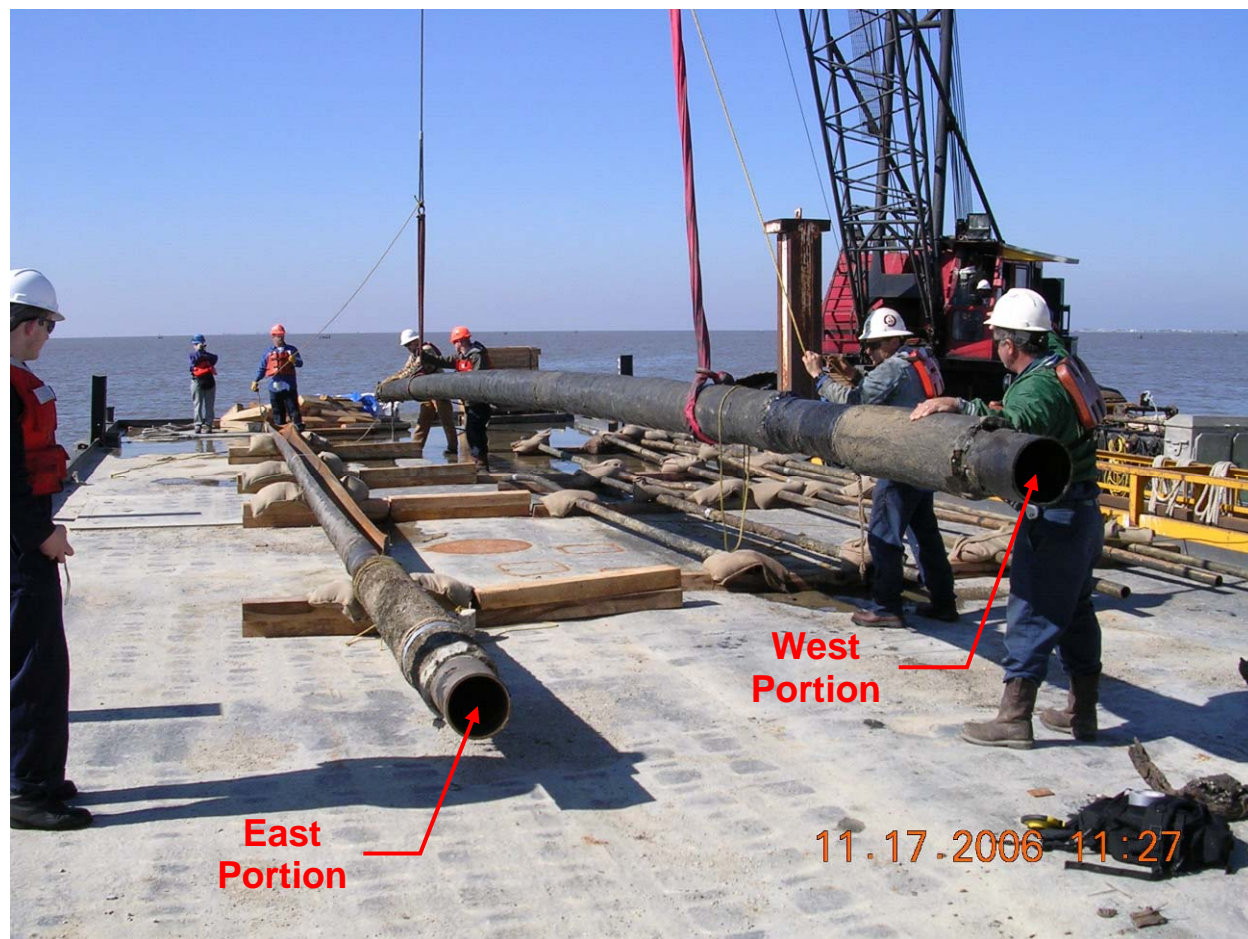
**Figure 4:** The east and west portions of the sales gas line during salvaging.

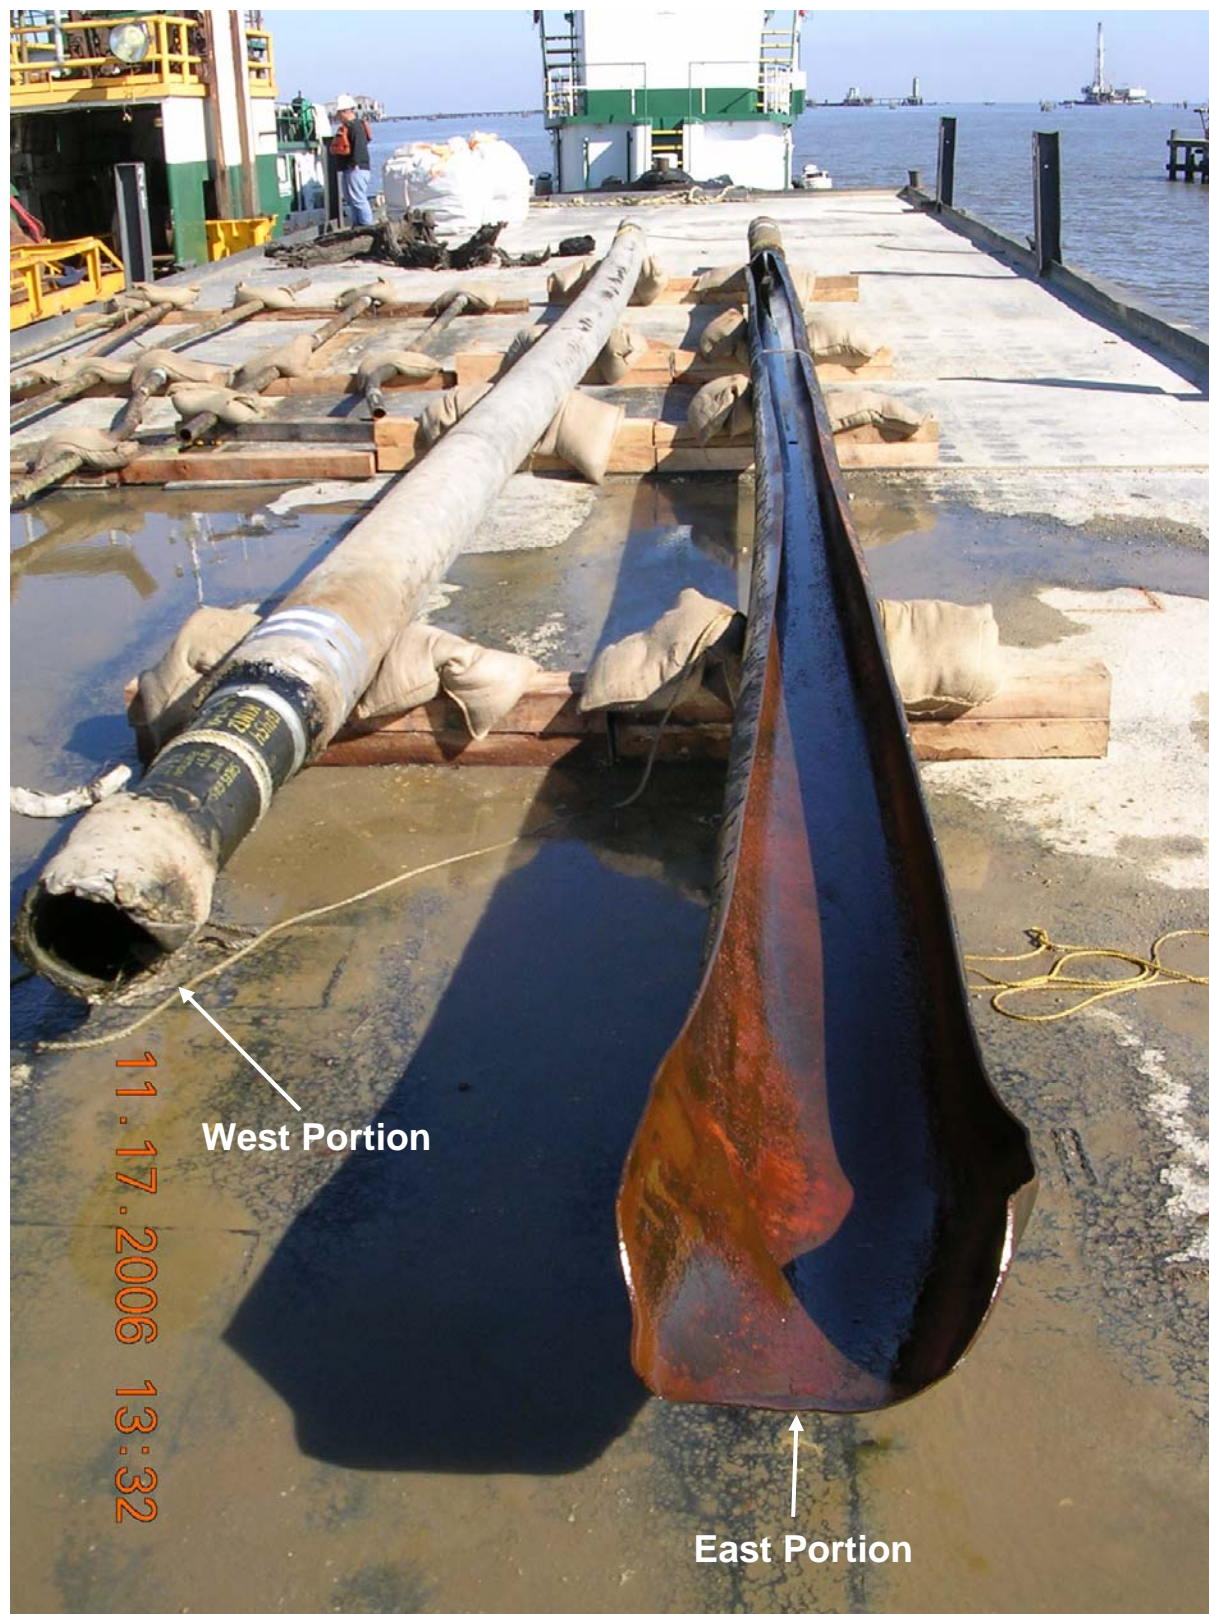
The exterior of the sales gas line pipes had been coated with a plant applied, spiral wrapped, asphalt-type coating shown in Figure 44, except for the ends that were welded in the field. The pipes were then coated with wire-reinforced concrete on top of the spiral wrapped asphalt (Figures 5, 6, 13, 16, 18, and 20). The thickness of the concrete ranged from 1.2 to 1.5 inches in

**Figure 5:** The east and west portions of the sales gas line shortly after salvaging as viewed from their mating, transverse-fractured ends.

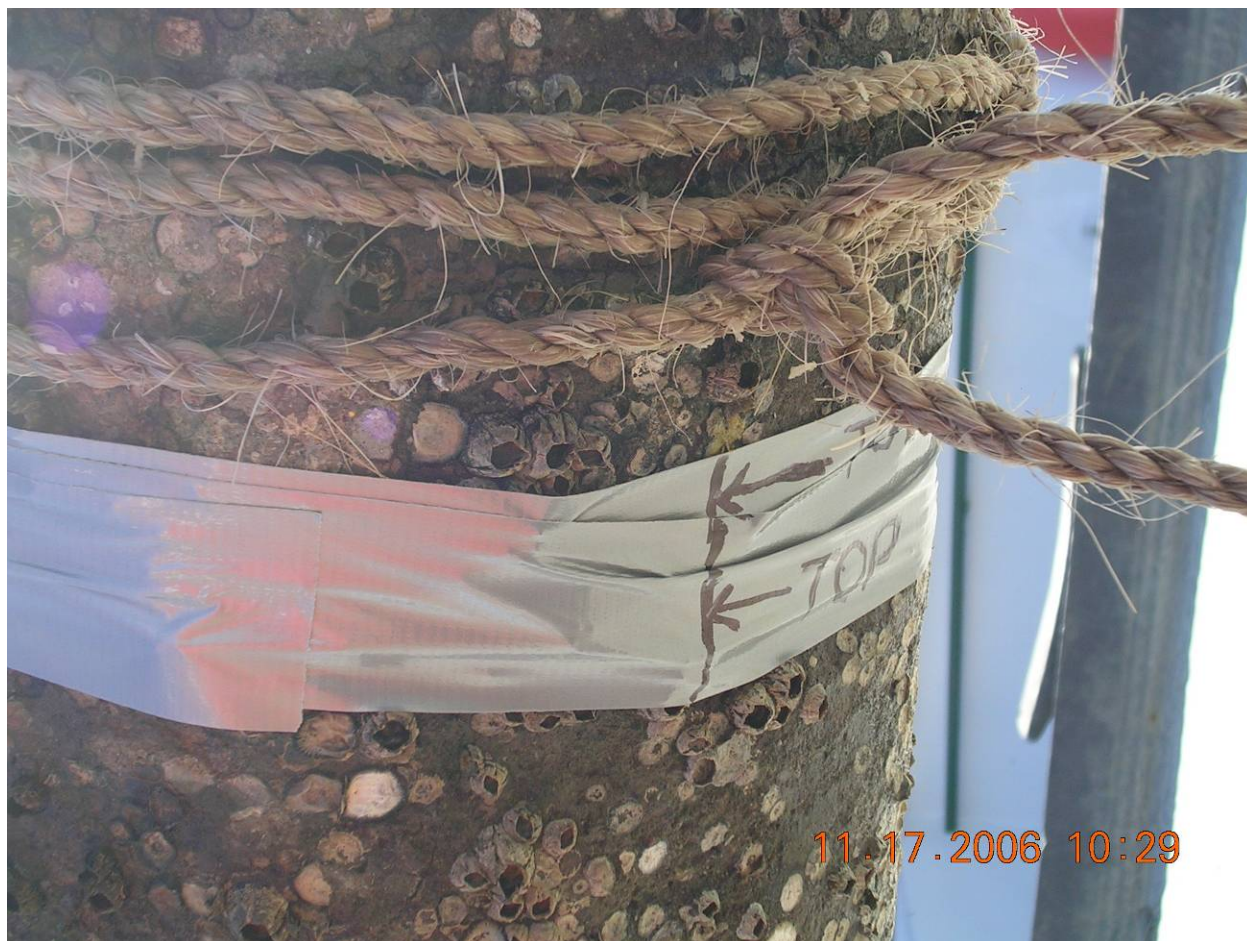
Before the sales gas line pipe samples were lifted from the bottom of West Cote Blanche Bay, divers tied ropes around the circumference of the samples with the knots positioned at the geometric top of the pipe. Figure 8 shows the knotted rope on the east portion shortly after salvaging. Figure 9 shows the knotted rope on the west portion of the sales gas line. In the laboratory, the east portion was rotated such that the rope knot was at the bottom. Photographs were then taken to show the position of the longitudinal fracture (Figure 10). The longitudinal fracture was located in the vicinity of the geometric bottom of the pipe as it was found following

**Figure 8:** The knotted rope indicating the geometric top of the east portion of the sales gas line as the pipe was found after the rupture.

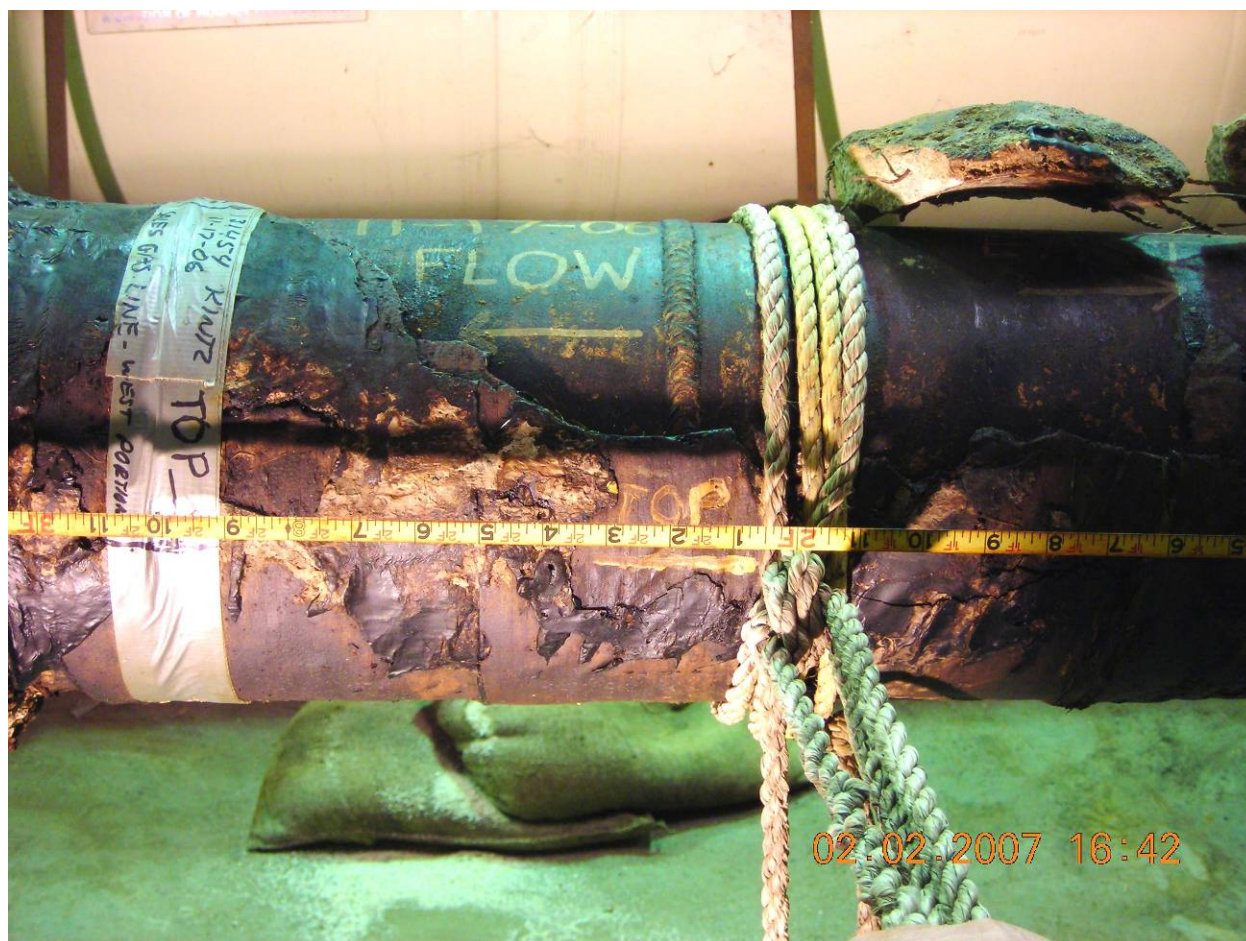
**Figure 9:** The knotted rope indicating the geometric top of the west portion of the sales gas line as the pipe was found following the rupture.
